### TYPICAL FASTENER PATTERN DETAIL

### INSTALLATION DETAIL

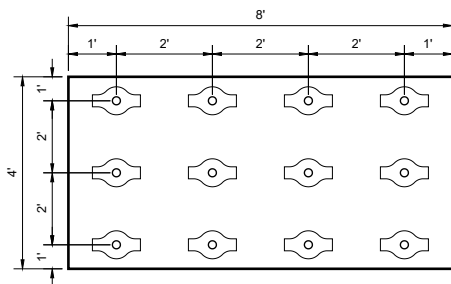
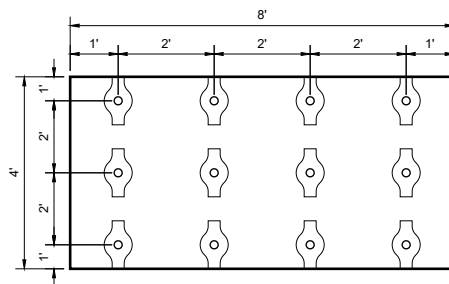
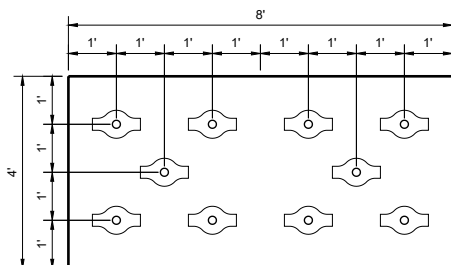
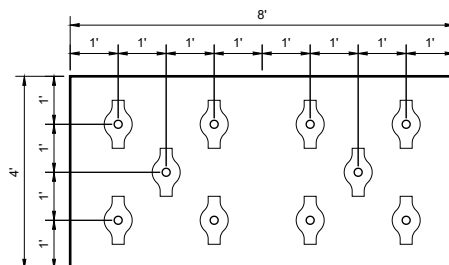
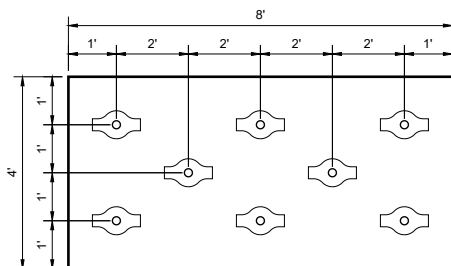
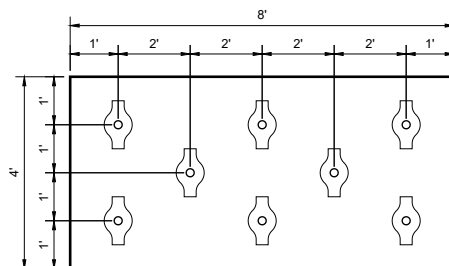
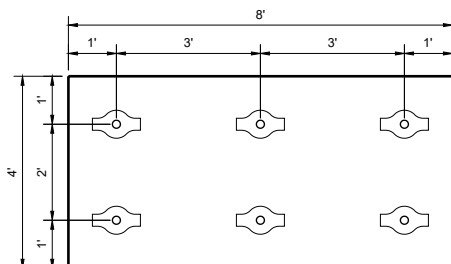
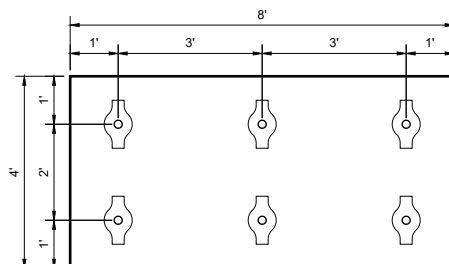
LR001

12 FASTENERS FASTENING PATTERN

10 FASTENERS FASTENING PATTERN

8 FASTENERS FASTENING PATTERN

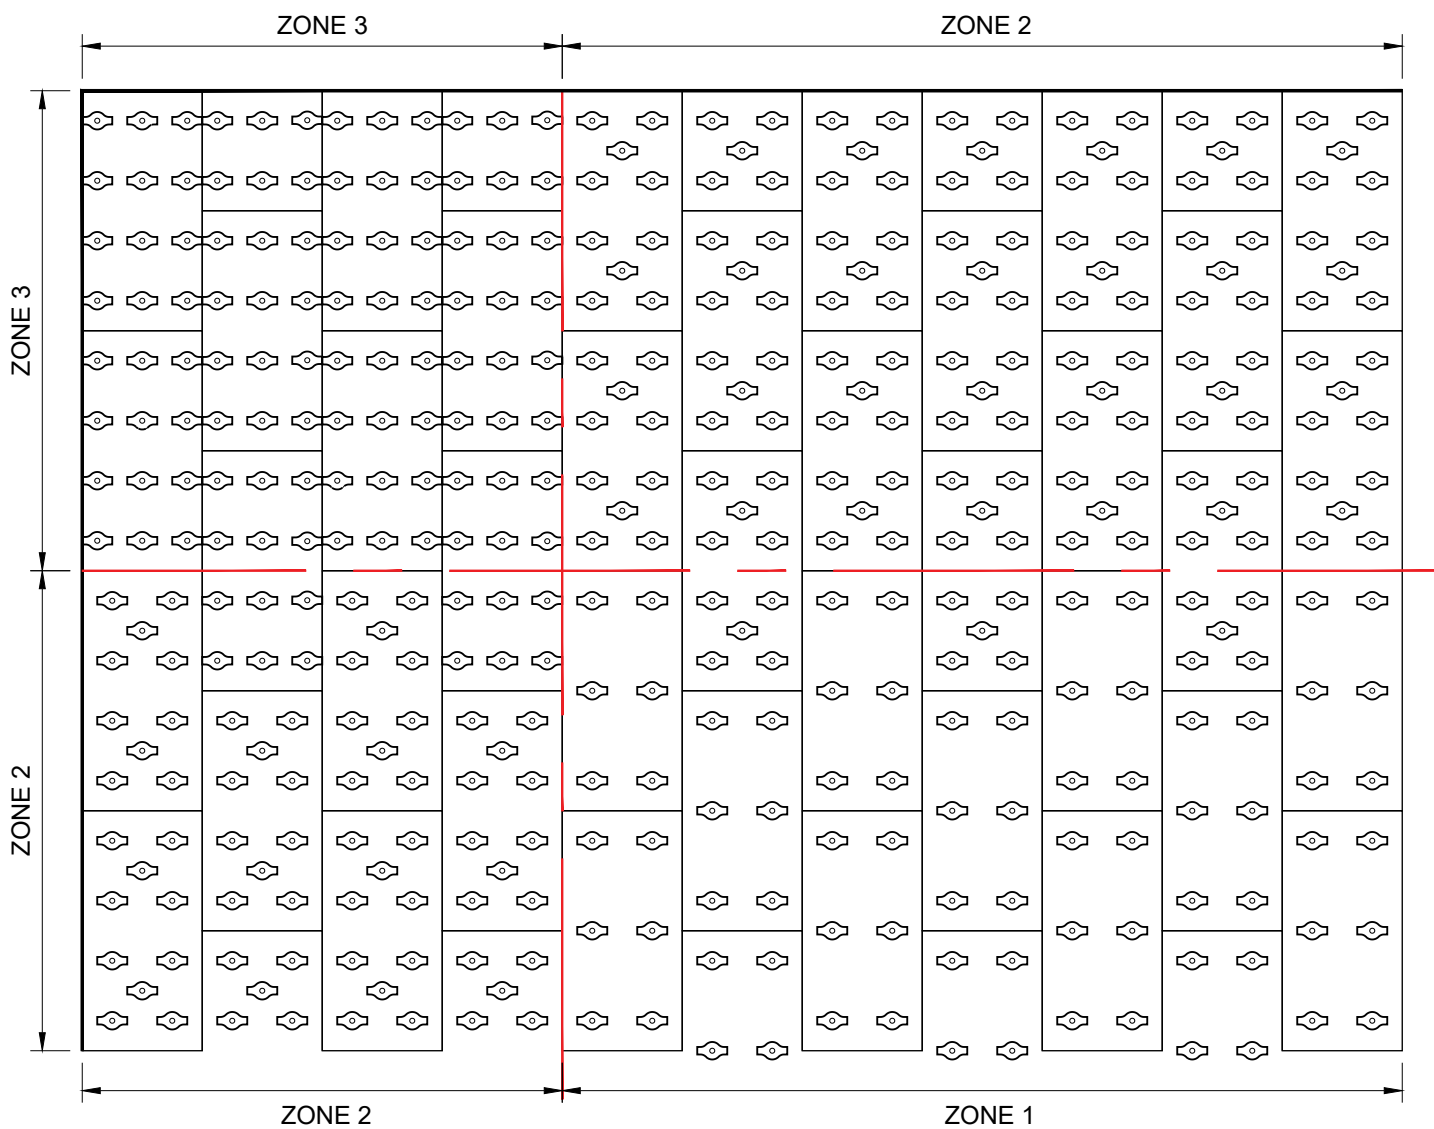
LR002

TYPICAL CORNER LAYOUT DETAIL FOR F.M. 1-190 OR LESS

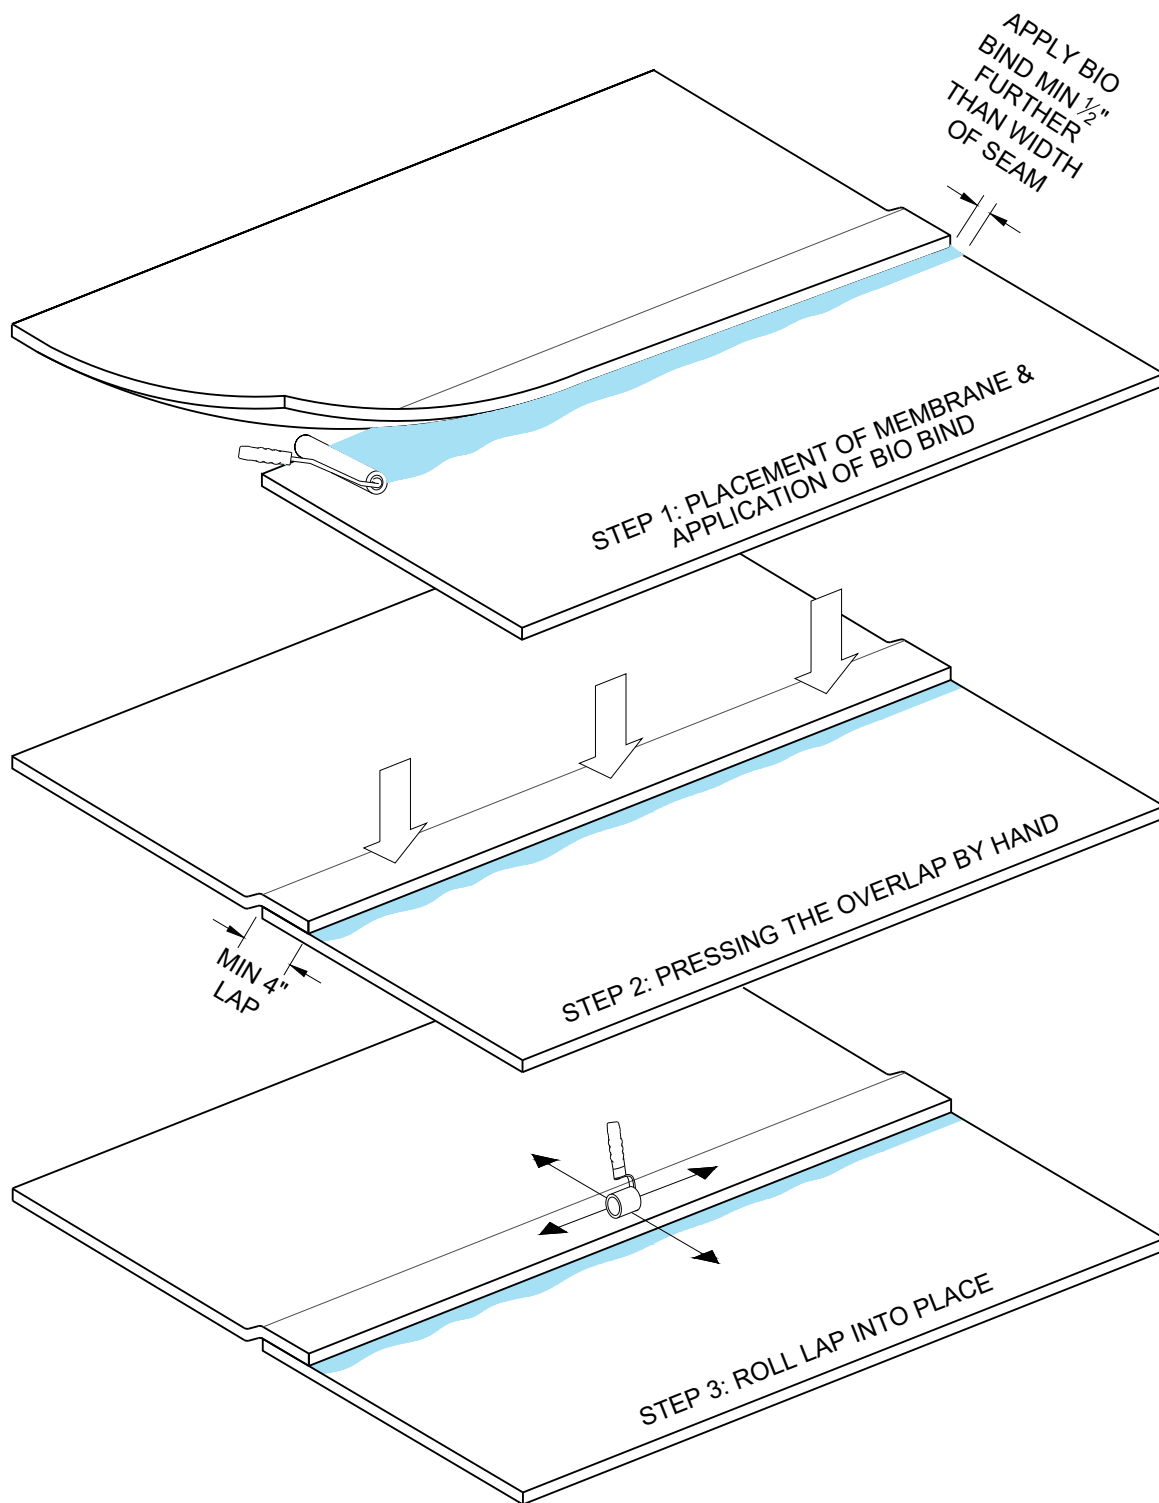
LR003

TYPICAL LAP ATTACHMENT DETAIL

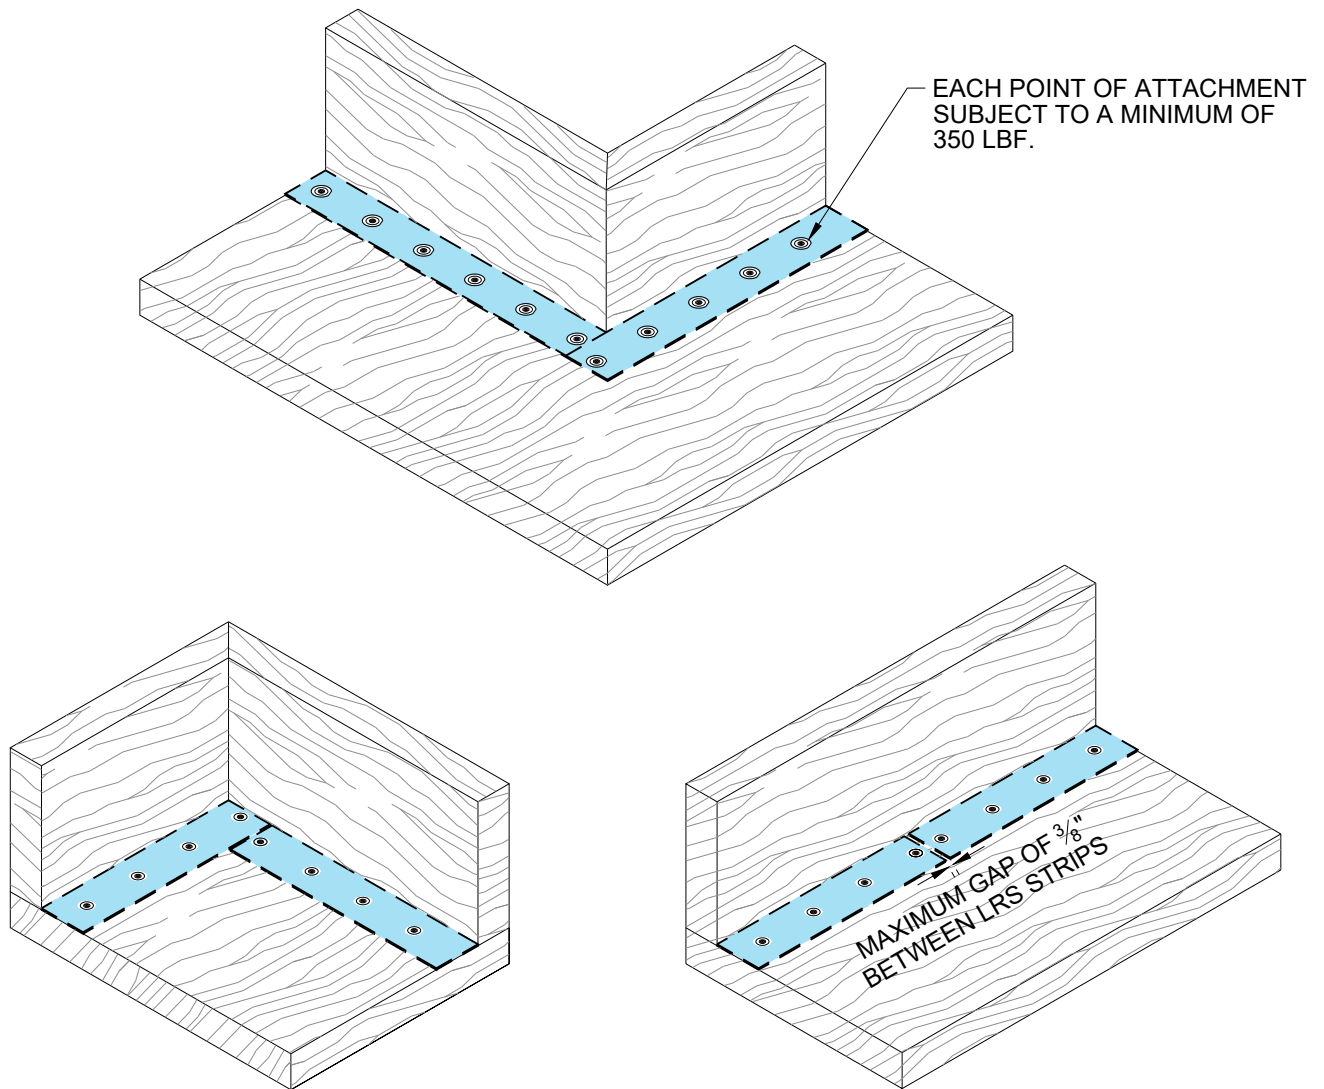
LR004

LEADAX LRS STRIPS MAY NOT OVERLAP AT  
INNER AND OUTER CORNERS.

LEADAX REINFORCED STRIP FASTENING

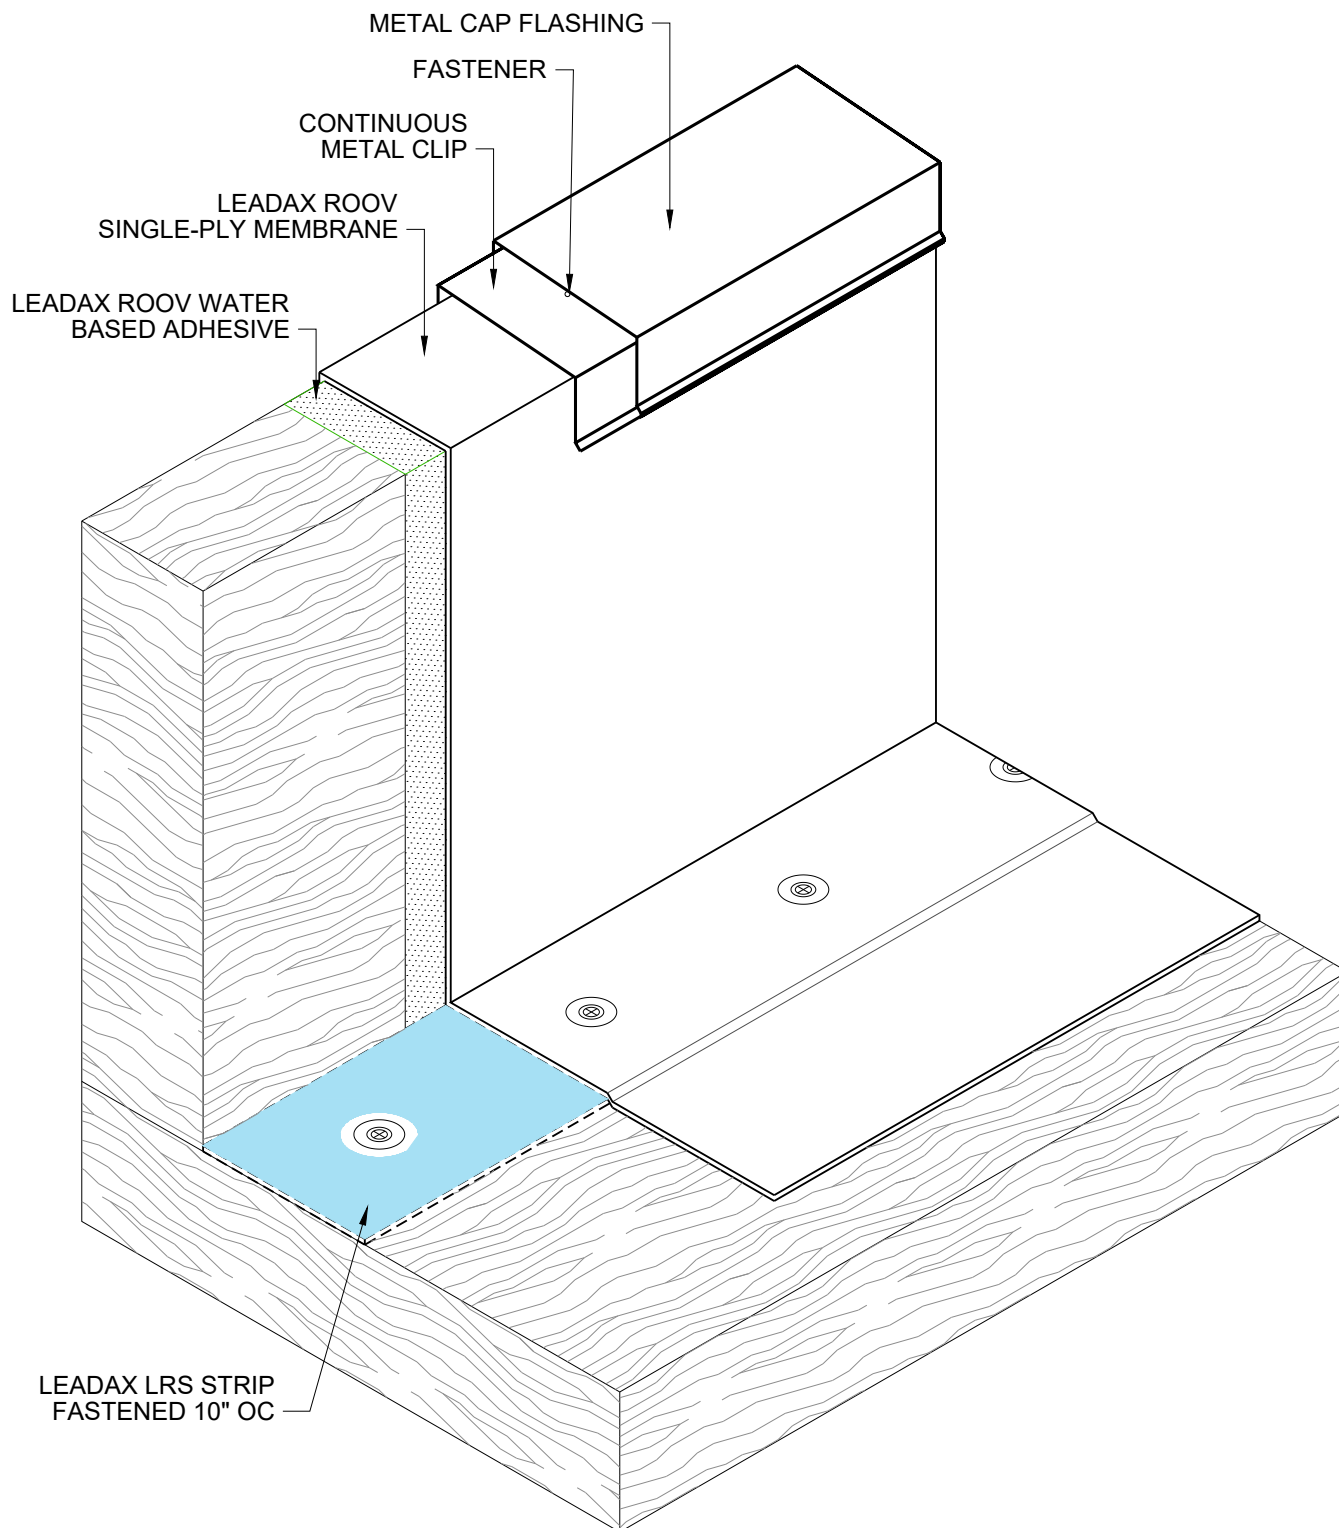
LR005

ASSEMBLY DETAIL WITH METAL COPING CAP FLASHING

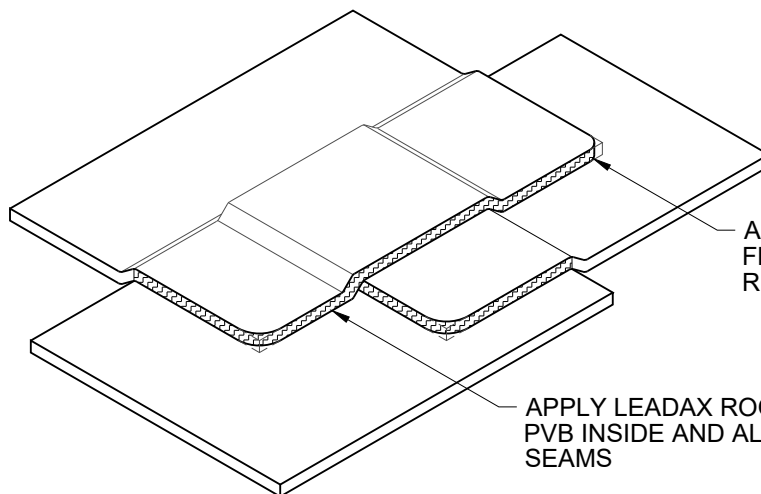
LR008

ALL FIELD CUT PATCHES AND  
FLASHINGS SHALL HAVE  
ROUNDED CORNERS

APPLY LEADAX ROOV LIQUID  
PVB INSIDE AND ALONGSIDE ALL  
SEAMS

TYPICAL T-LAP DETAIL

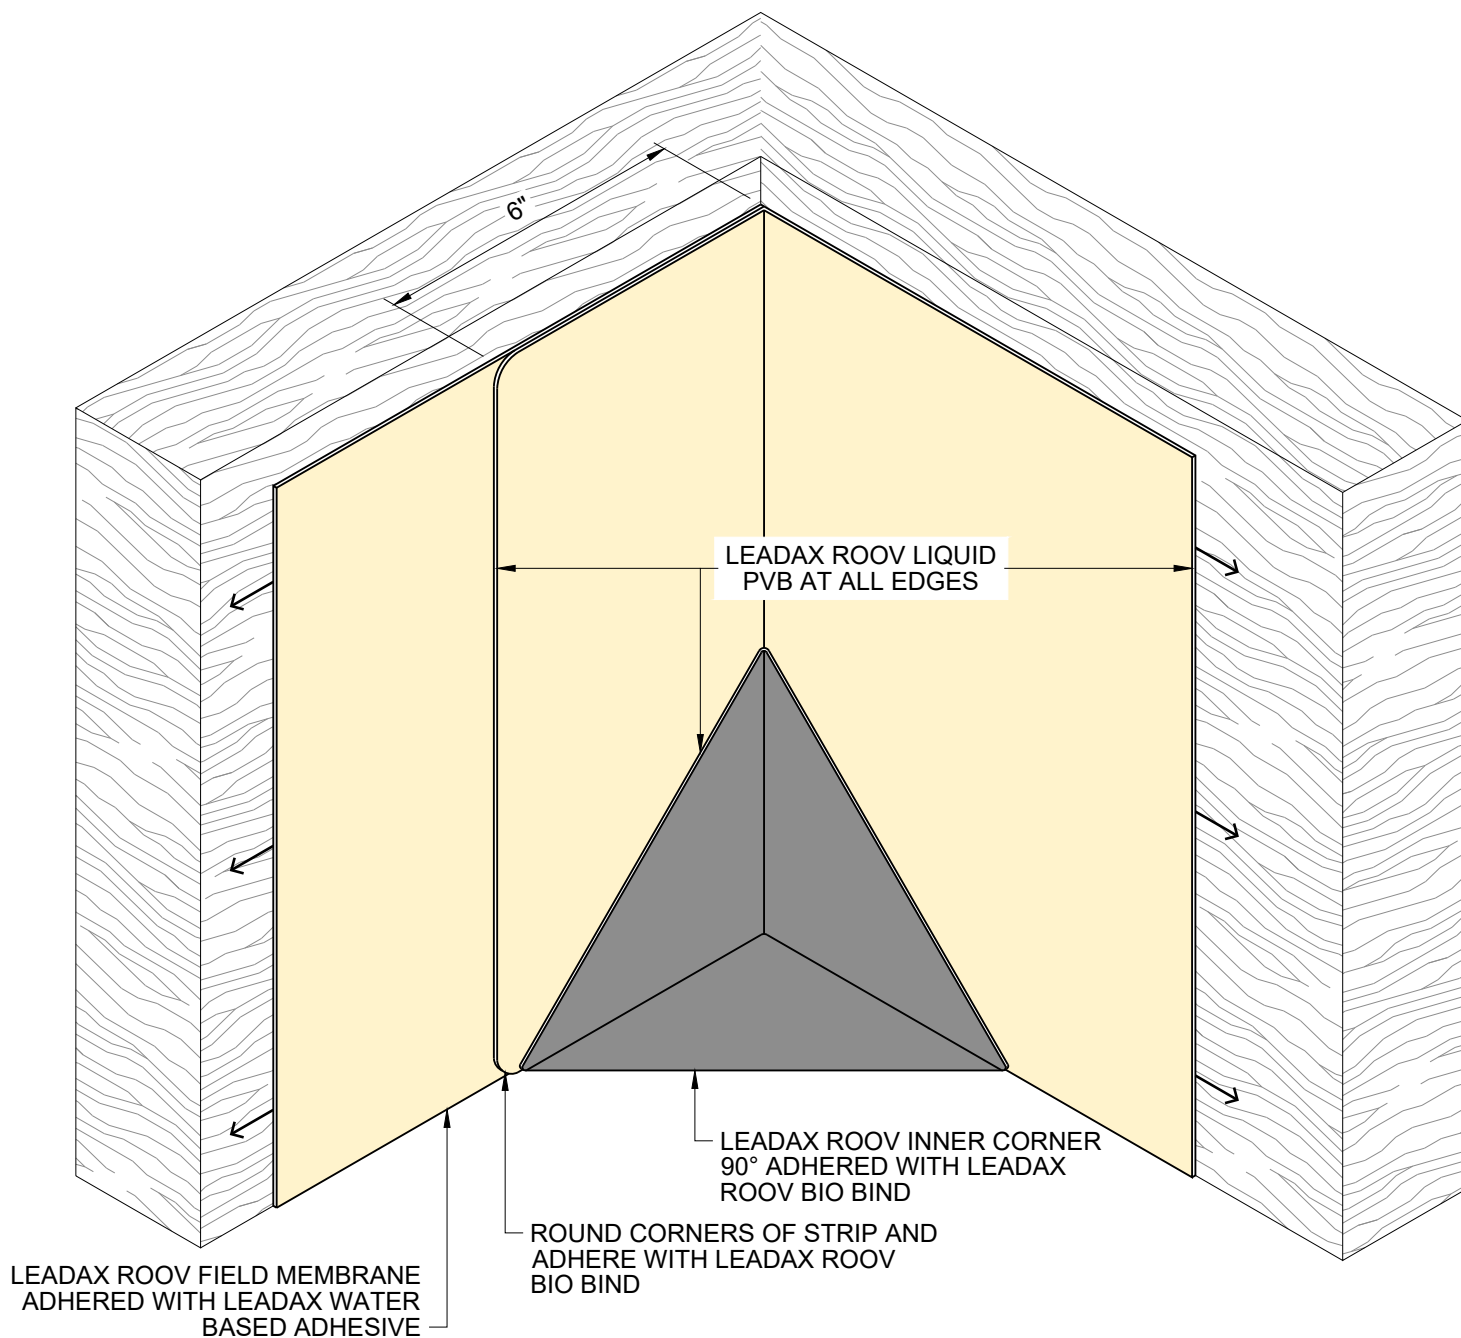
LR009

TYPICAL INSIDE CORNER FLASHING DETAIL

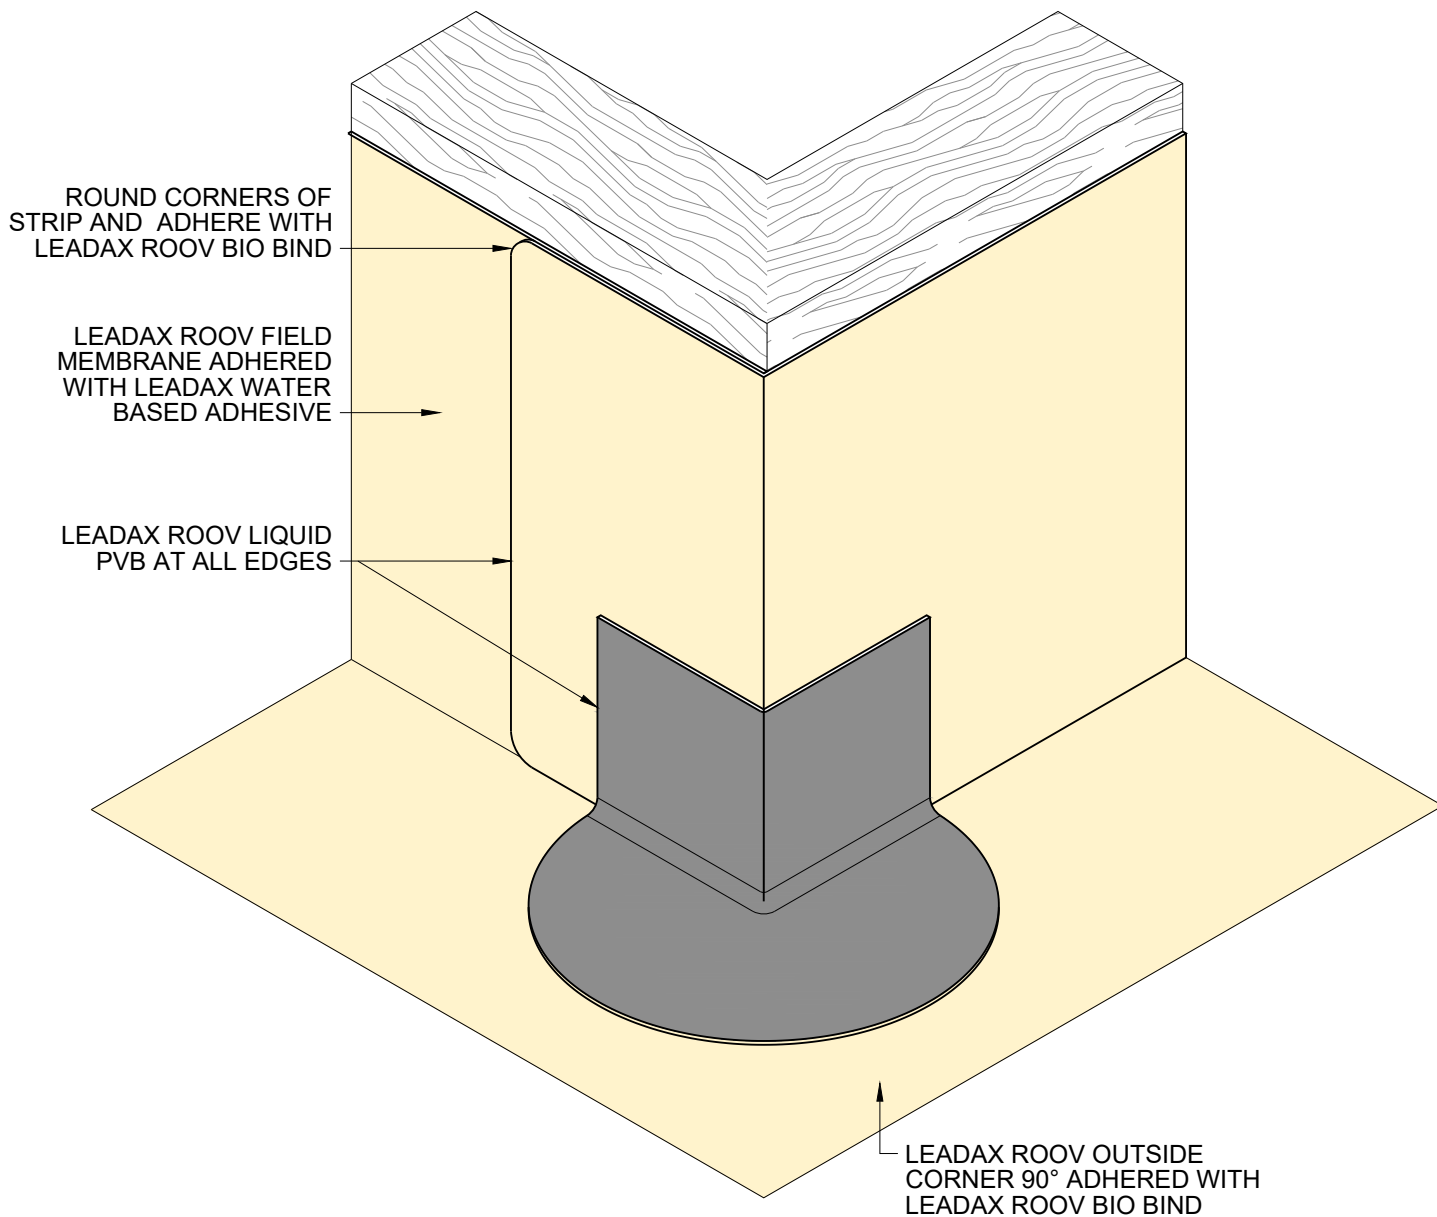
LR010

TYPICAL OUTSIDE CORNER FLASHING DETAIL

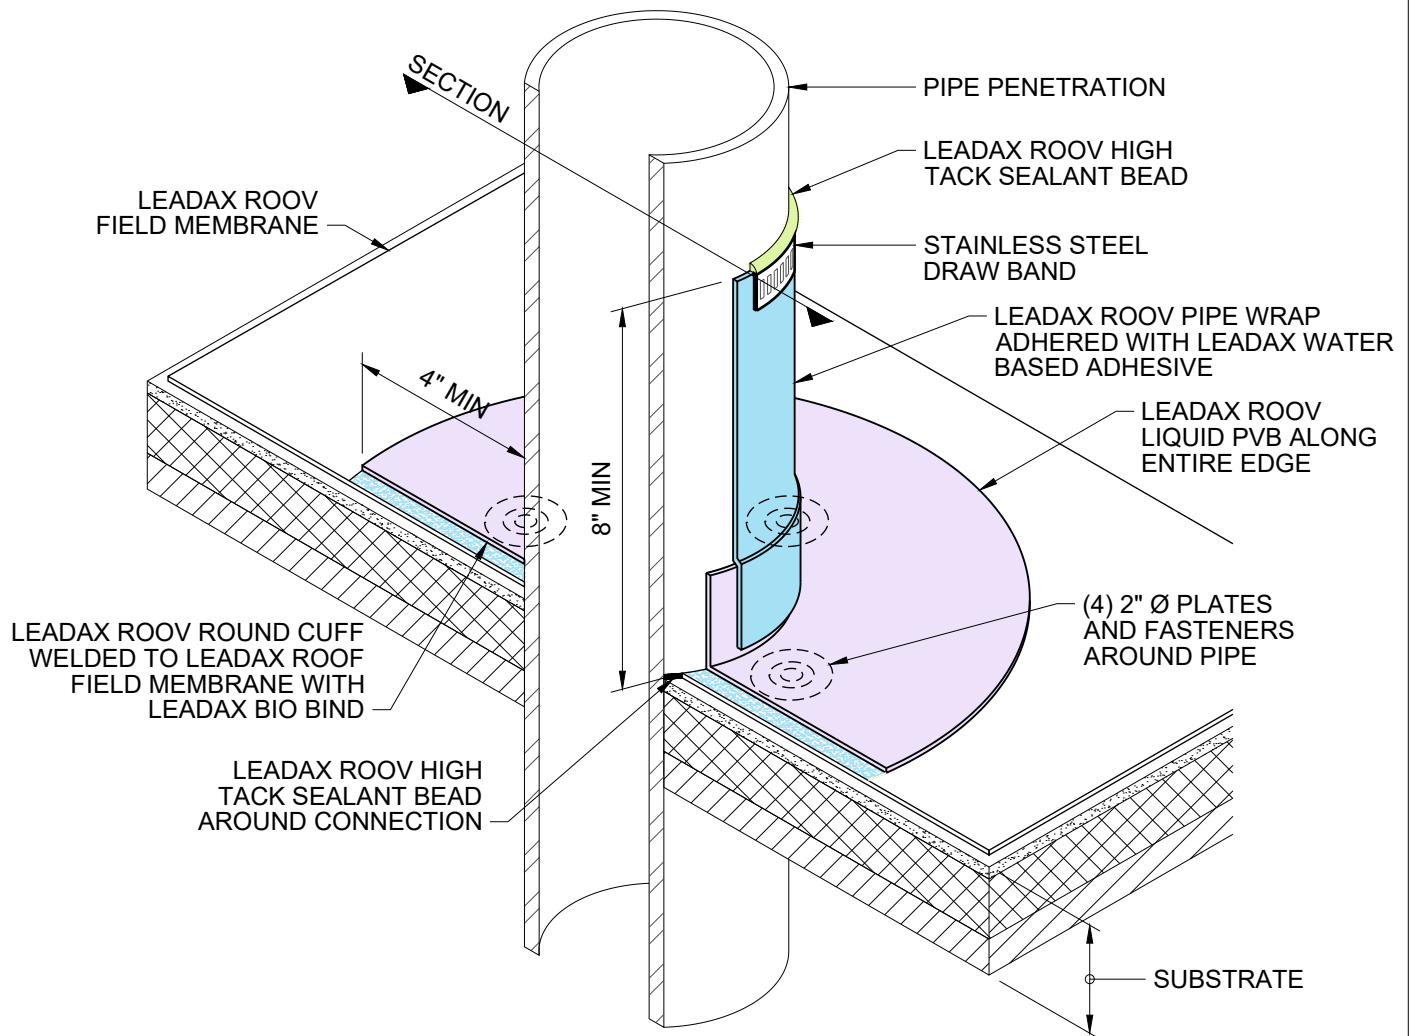
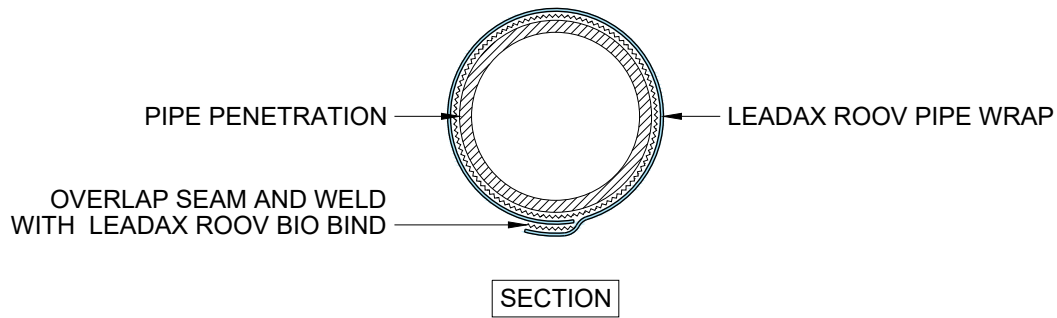
LR011

TYPICAL PIPE PENETRATION FLASHING DETAIL

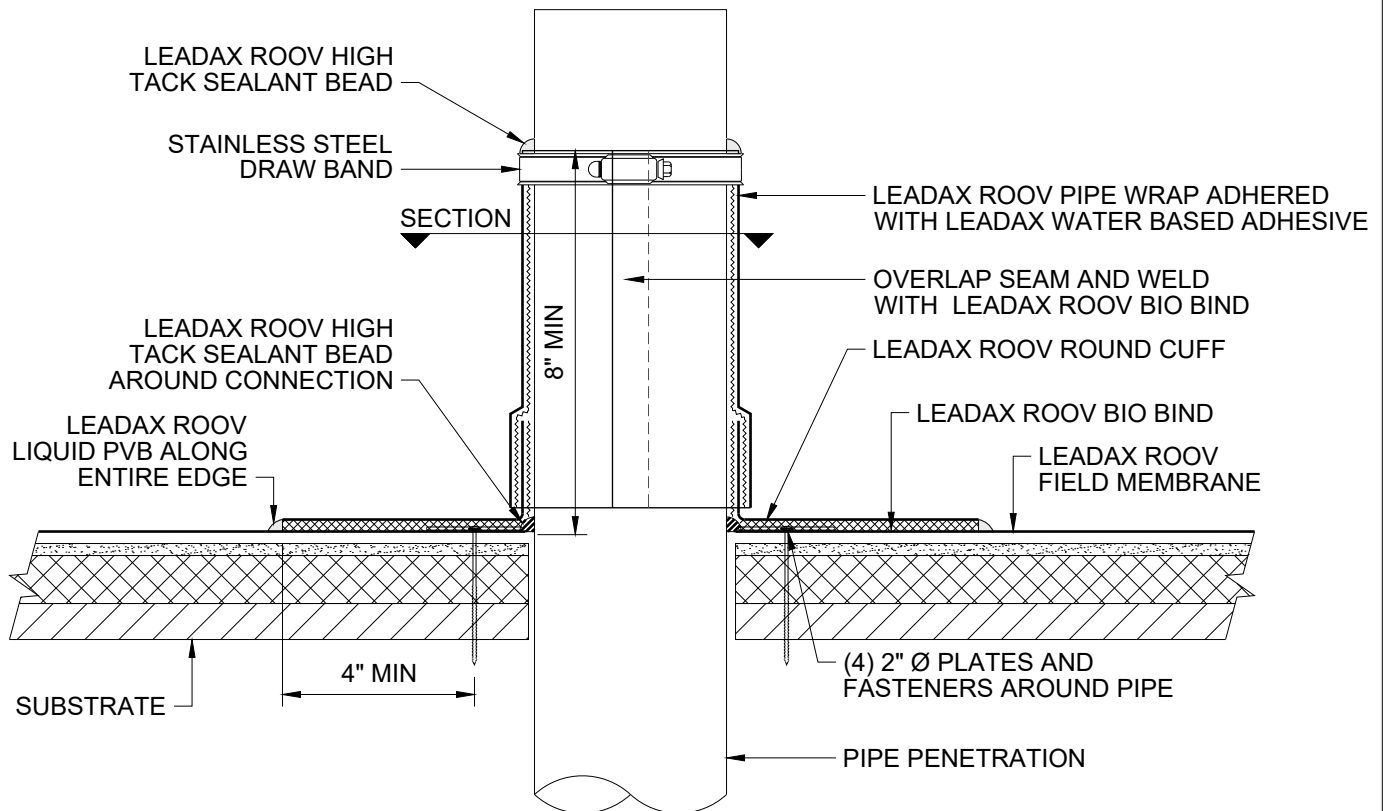
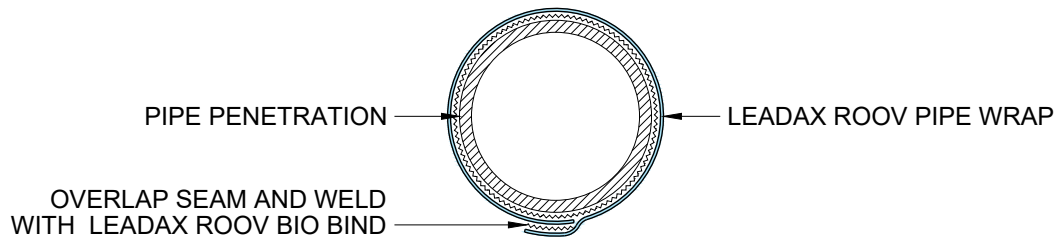
LR012

SECTION

[ALTERNATE]  
TYPICAL PIPE PENETRATION FLASHING DETAIL

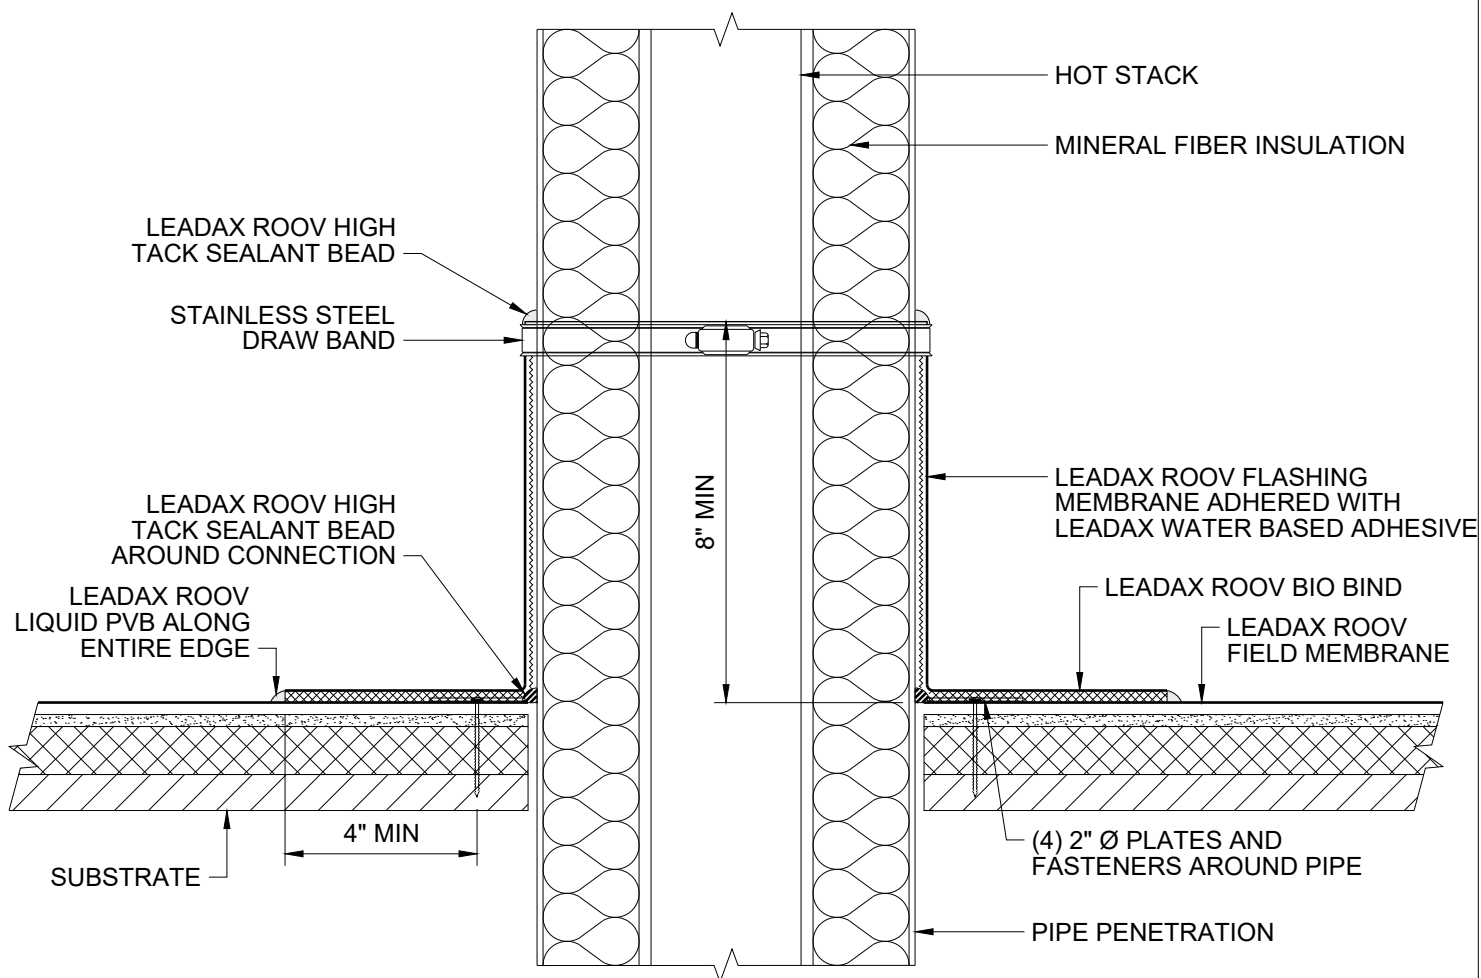
LR013

TYPICAL HOT STACK PENETRATION FLASHING DETAIL

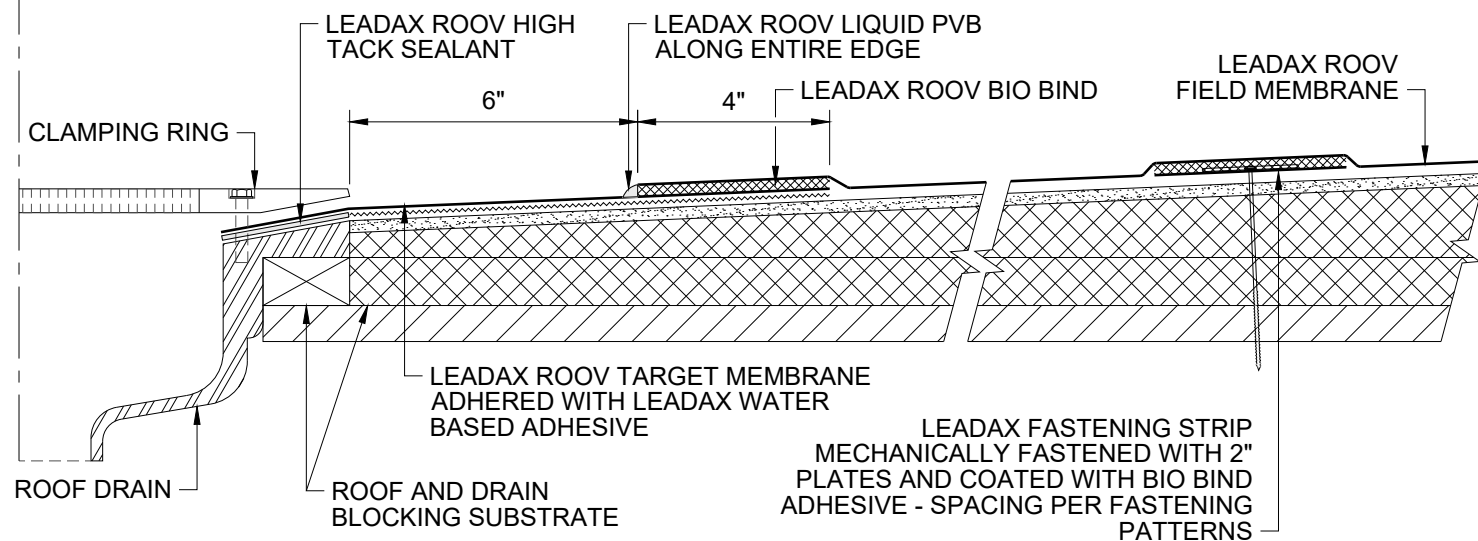
LR014

SYMMETRICAL  
ABOUT CENTERLINE

TYPICAL DRAIN FLASHING DETAIL

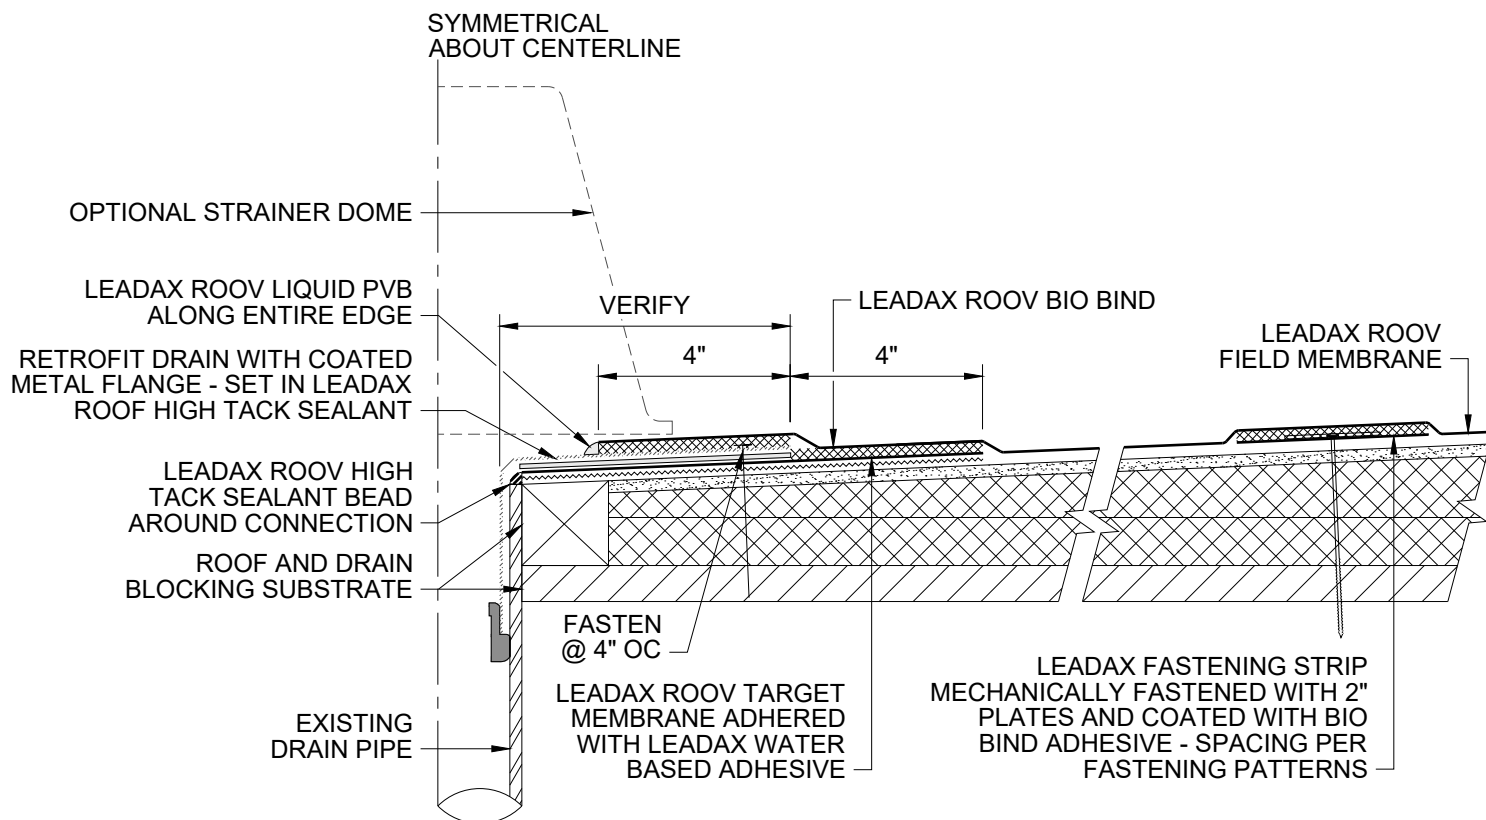
LR015

TYPICAL RETROFIT DRAIN INSERT FLASHING DETAIL

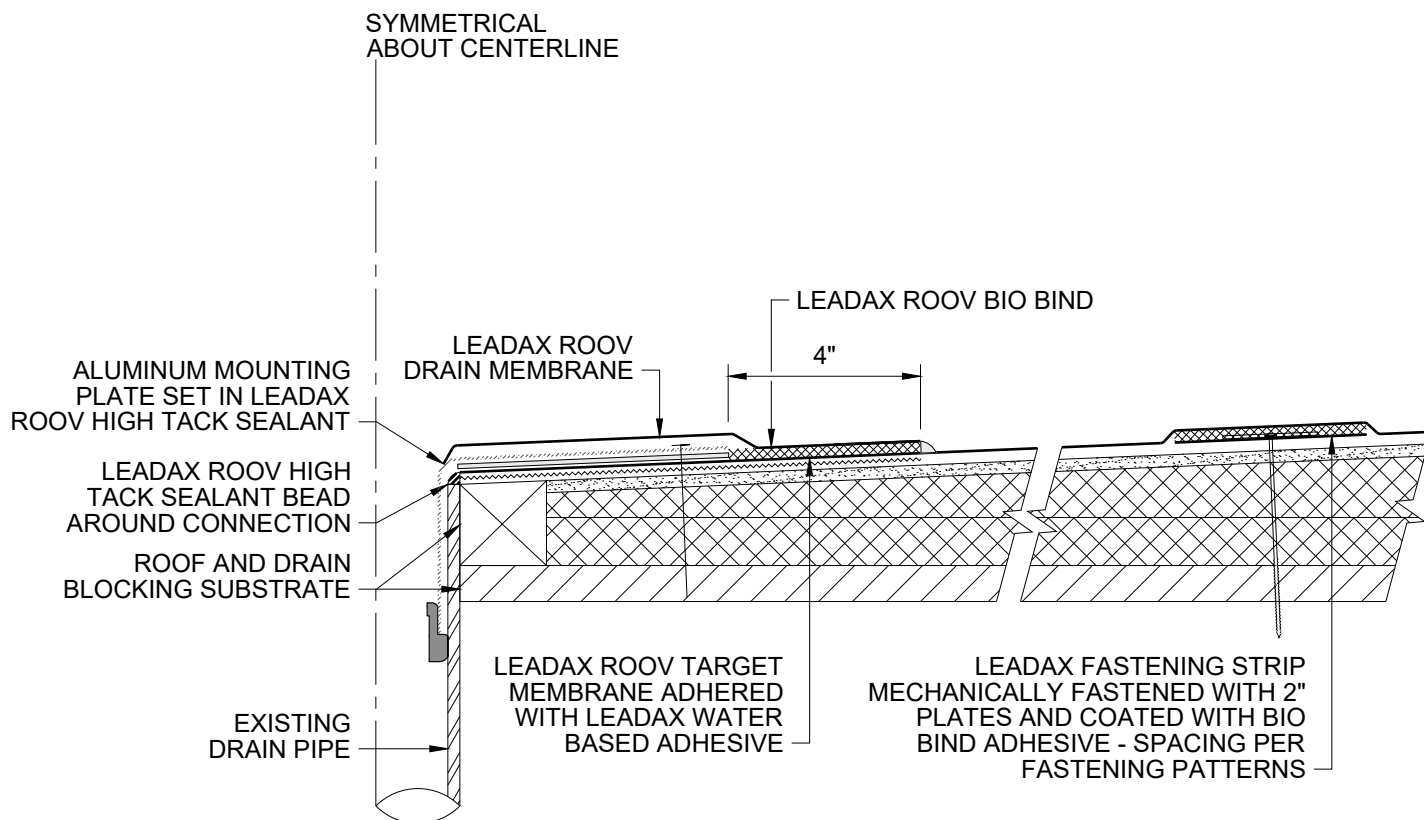
LR016

LEADAX DRAIN INSERT FLASHING DETAIL

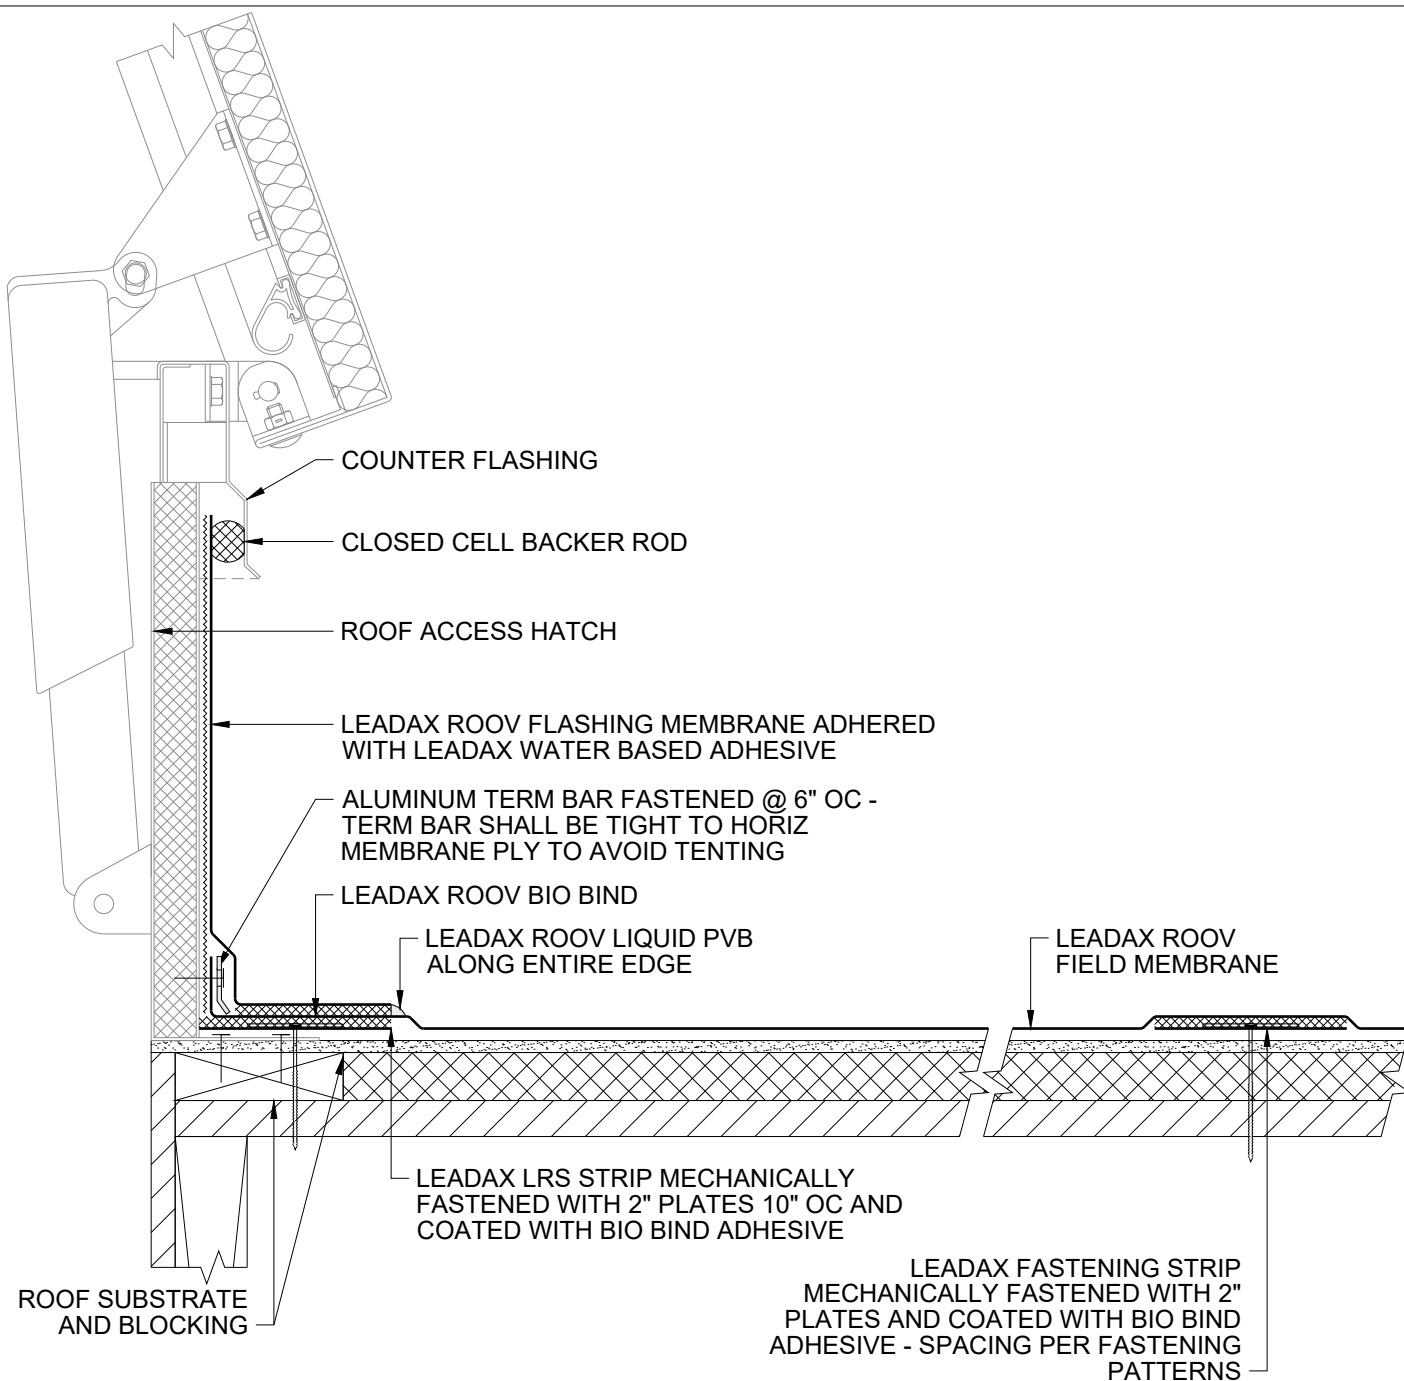
LR017

TYPICAL ROOF ACCESS HATCH FLASHING DETAIL

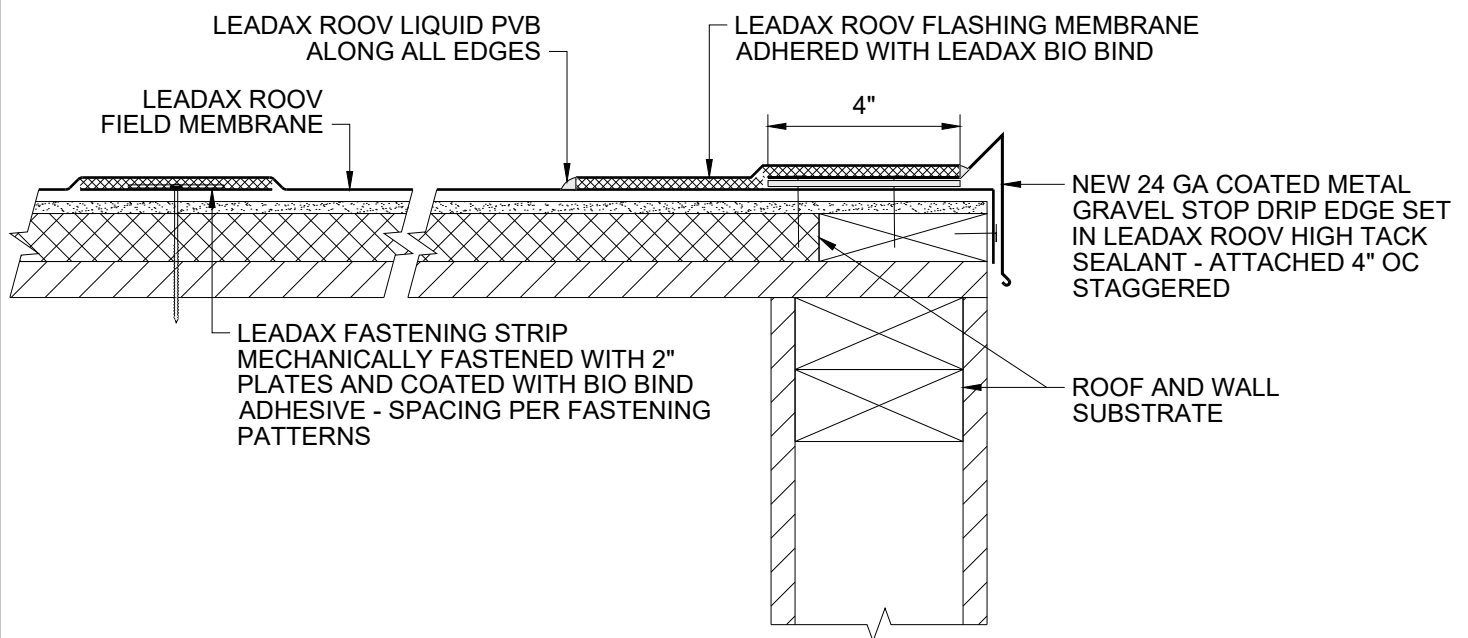
LR018

TYPICAL ROOF EDGE GRAVEL STOP FLASHING DETAIL
