### TYPICAL FASTENER PATTERN DETAIL

### INSTALLATION DETAIL

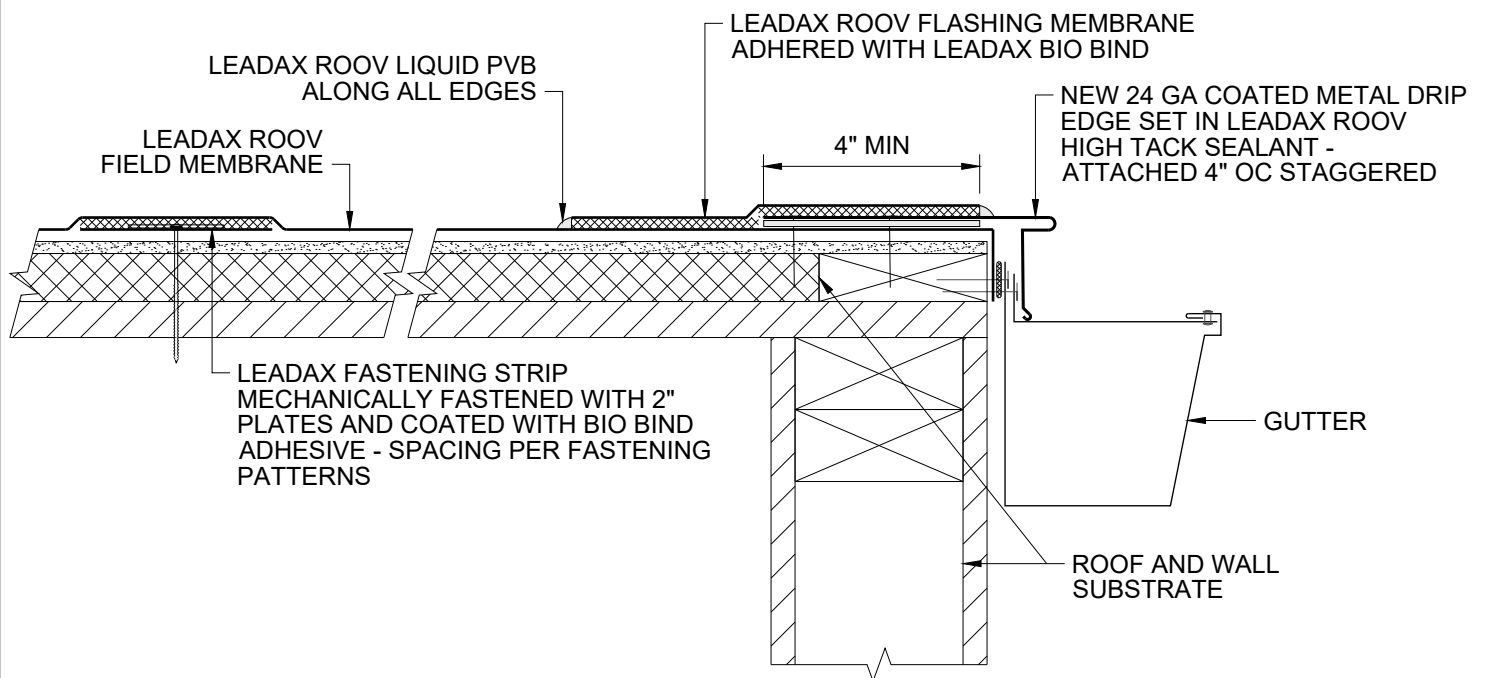
LR019

TYPICAL ROOF EDGE GUTTER FLASHING DETAIL

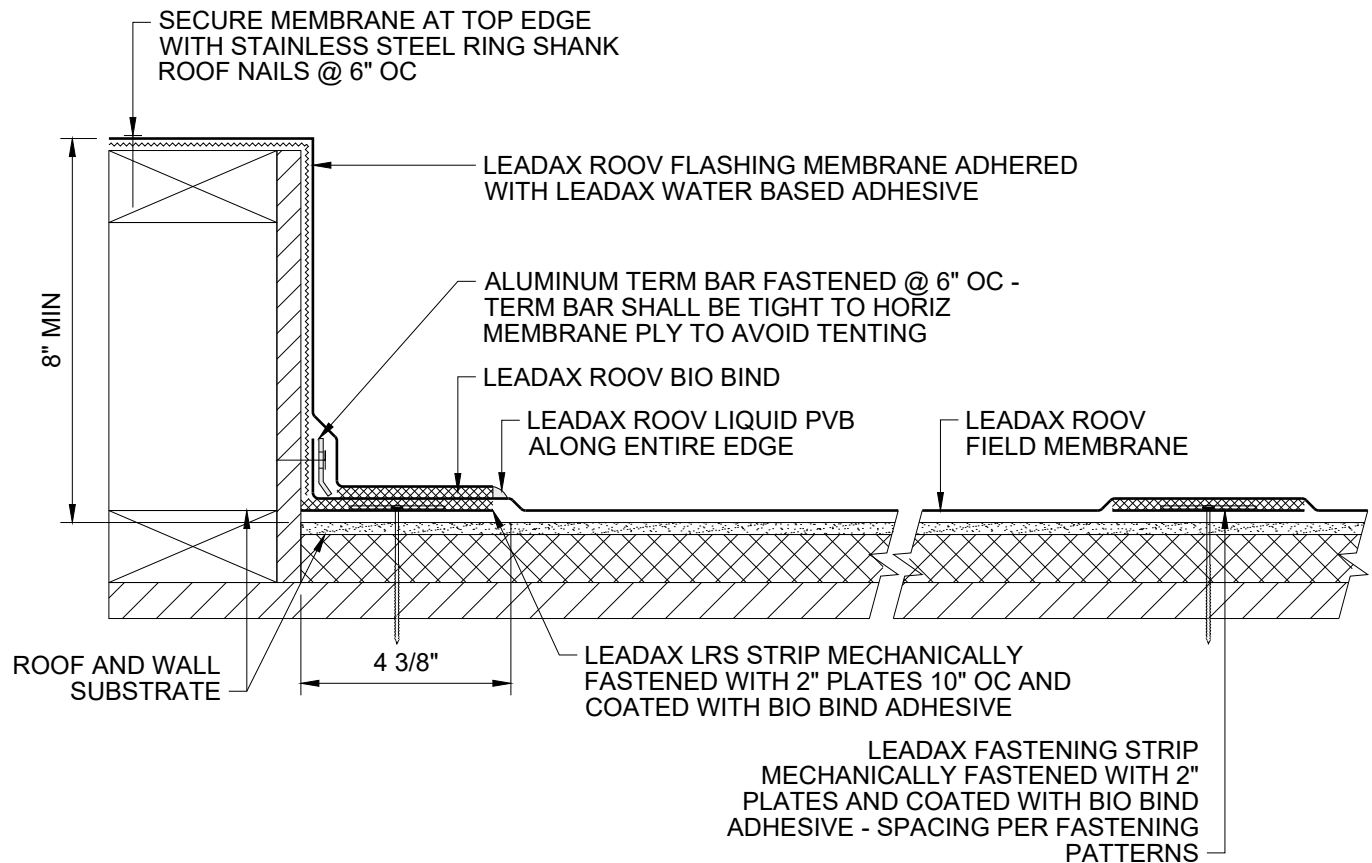
LR020

NOTE:  
WHERE WALLS HAVE TRACES OF ASPHALT,  
INSTALL SEPARATION LAYER OF CEMENT  
BOARD OR PLYWOOD AS NEW SUBSTRATE

TYPICAL BASE FLASHING DETAIL

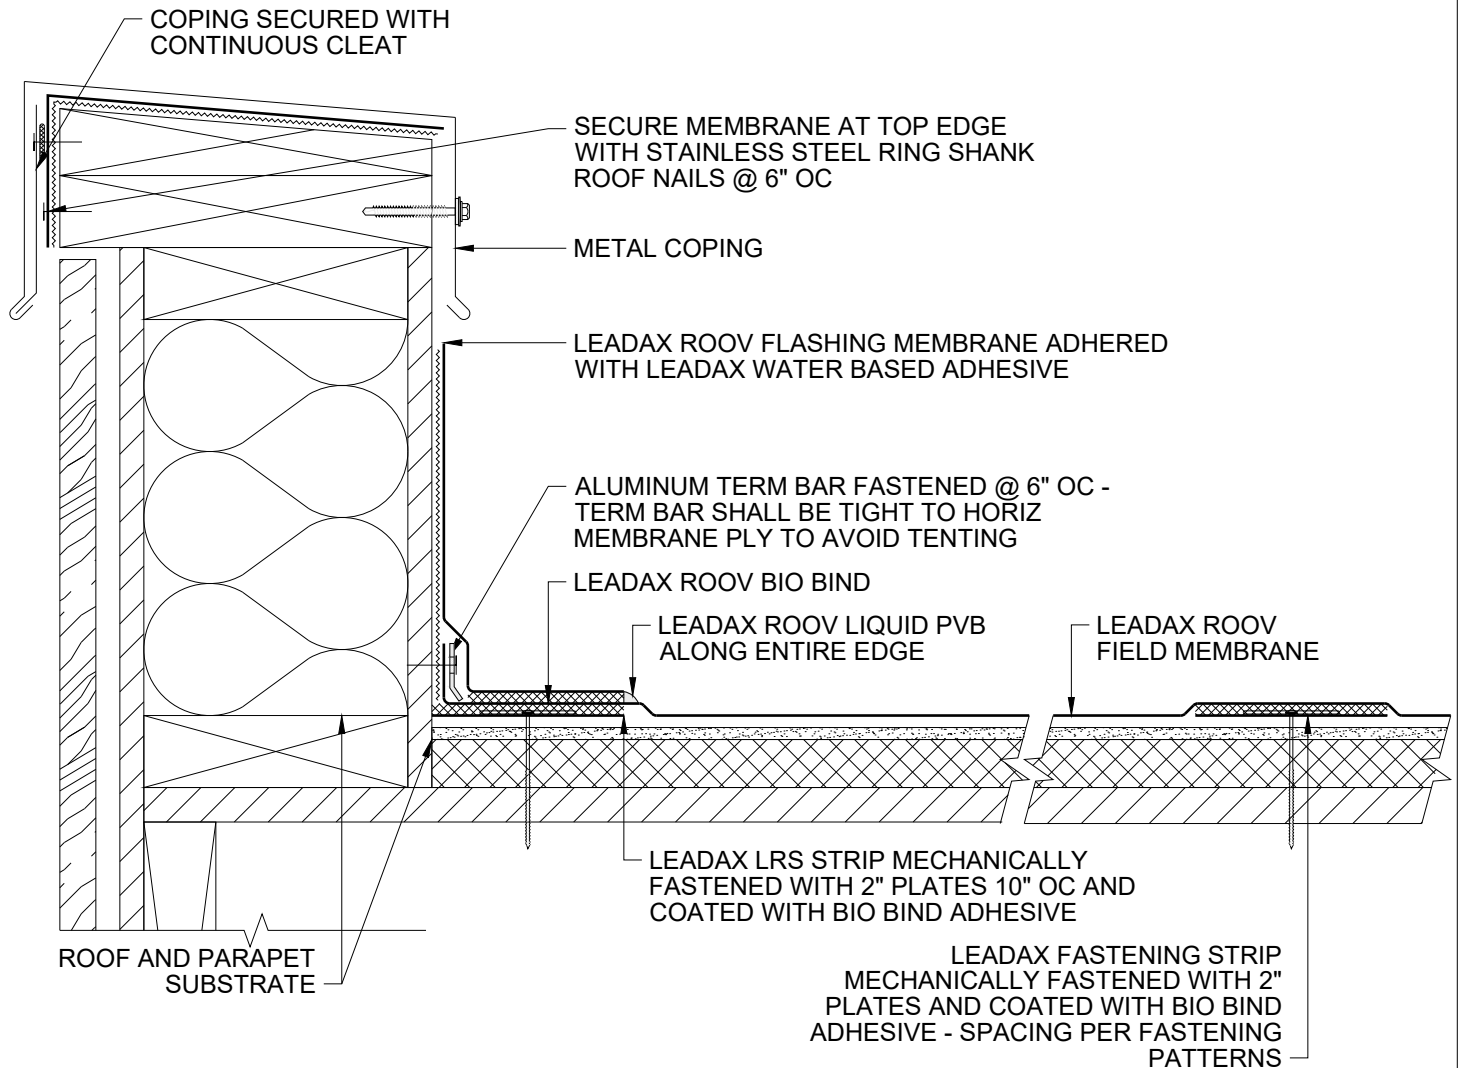
LR021

**NOTE:**  
WHERE WALLS HAVE TRACES OF ASPHALT,  
INSTALL SEPARATION LAYER OF CEMENT  
BOARD OR PLYWOOD AS NEW SUBSTRATE

TYPICAL COPING FLASHING DETAIL

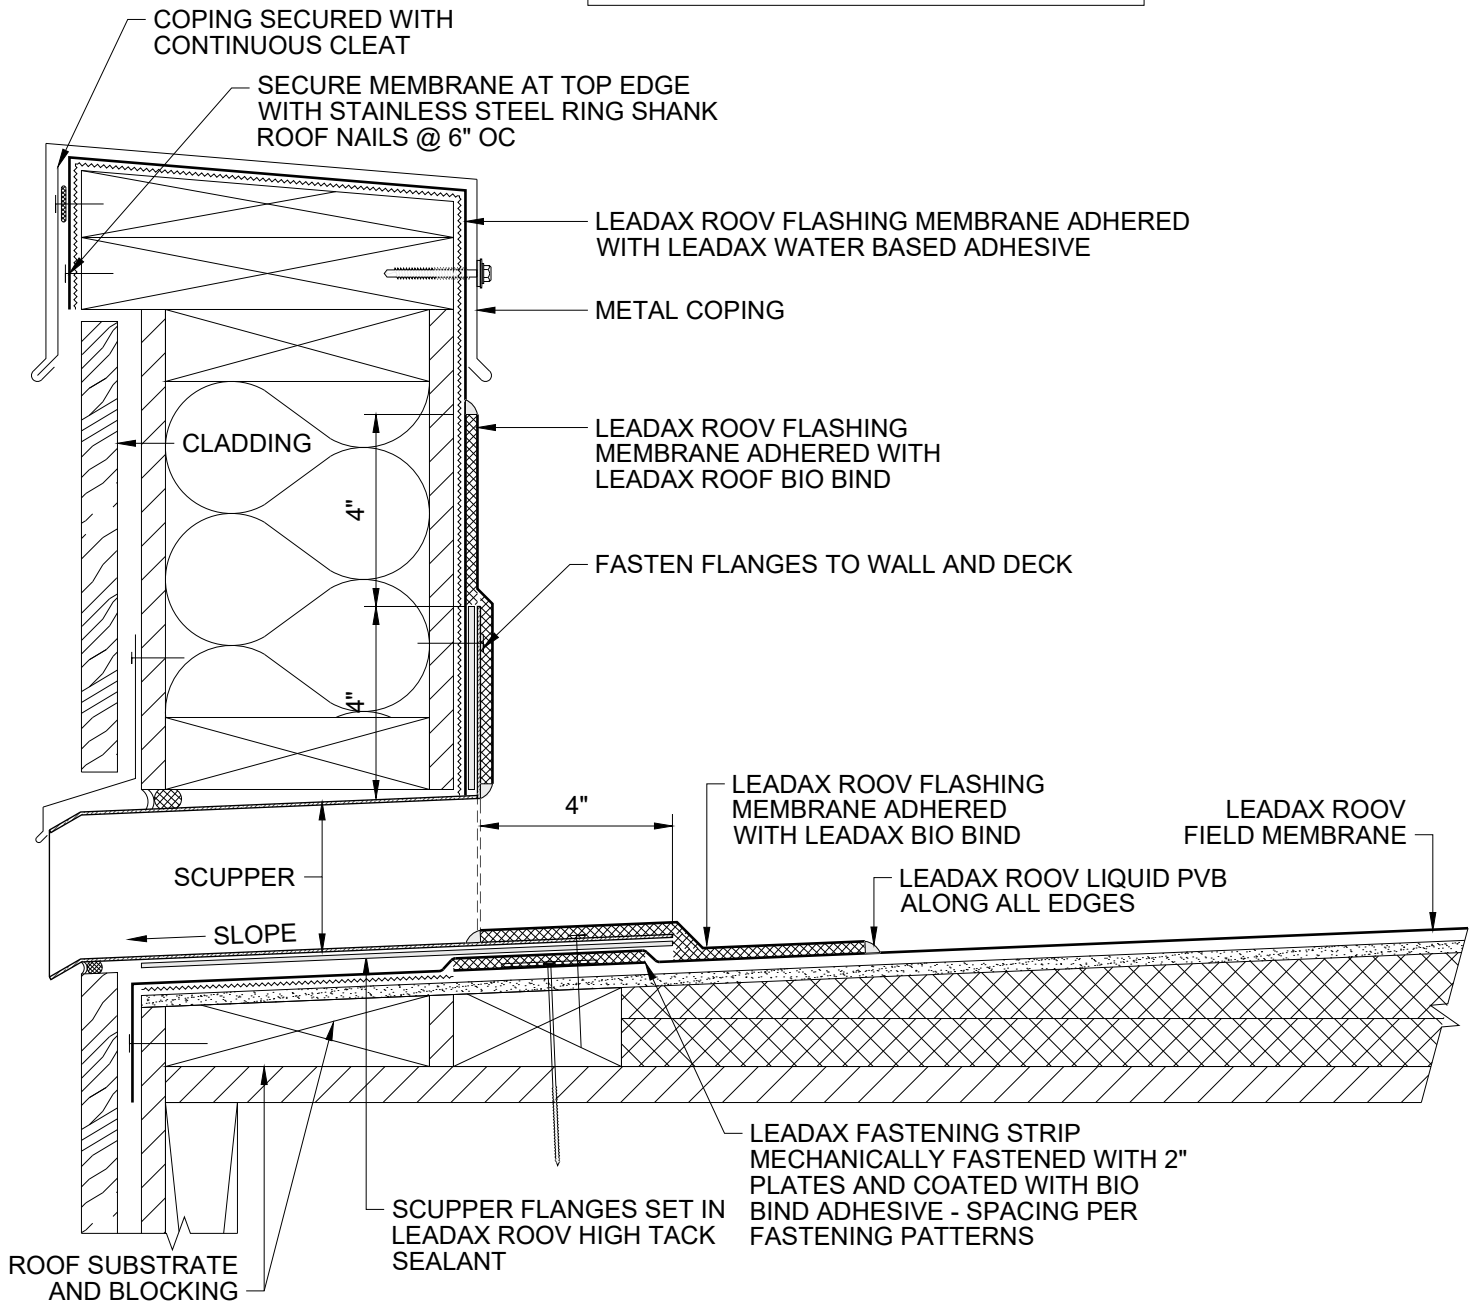
LR022

NOTE:  
WHERE WALLS HAVE TRACES OF ASPHALT,  
INSTALL SEPARATION LAYER OF CEMENT  
BOARD OR PLYWOOD AS NEW SUBSTRATE

TYPICAL SCUPPER FLASHING DETAIL
